# *Impulse Flashover Characteristics Of Oil Palm Trunk (OPT) Veneer Plywood*

The increased use of plywood as a substitute for timber exposes it to instances of high voltage conditions such as lightning. This study looks into the High Voltage (HV) surface flashover characteristics of OPT plywood with parallel and perpendicular fiber orientations, under clean and polluted surfaces.

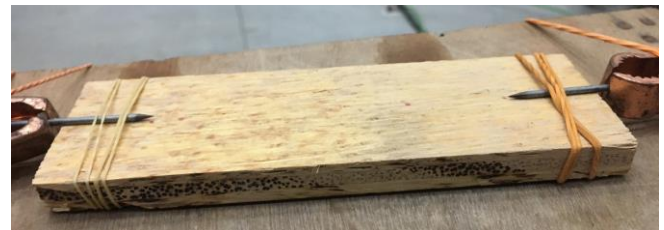
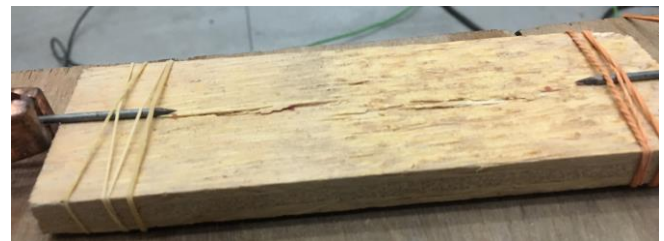
Figure 3: Bentonite contaminated sample with parallel fiber orientation before and after 25 voltage impulses (12 breakdowns)

Results of the experiment are illustrated in Table 1. Highest 50% breakdown voltage is recorded for the sample with fibre orientation parallel to the gap length and the surface is clean and dry. After the application of up and down method, the surface of the sample showed fractures and damage to the fibres. However, the highest observed damage and fractures to the fibres were present in the sample with fibre orientation parallel to the gap length and the surface was contaminated with bentonite, illustrated in Fig 3.

The area of the damage is clearly visible along the channel of the current at breakdown between the rods.  $V_{50\%}$  was significantly lower in the wet sample with fibre orientation parallel to the gap length. However, in this case, the standard deviation was almost comparable with the  $V_{50\%}$  value.

Hence, it can be stated with certainty that if an arc occurs parallel to the fibers the damage will be severe, and the degradation of the material will be apparent to the naked eye. Further, a wetted surface has a much high chance of an arc occurring as the breakdown voltages are significantly lower. However, any structural damage was not visible to the naked eye, though a reasonable conclusion can be drawn towards the degradation of the sample as a pungent order was given off after each impulse.
