# *Impulse Flashover Characteristics Of Oil Palm Trunk (OPT) Veneer Plywood*

The increased use of plywood as a substitute for timber exposes it to instances of high voltage conditions such as lightning. This study looks into the High Voltage (HV) surface flashover characteristics of OPT plywood with parallel and perpendicular fiber orientations, under clean and polluted surfaces.

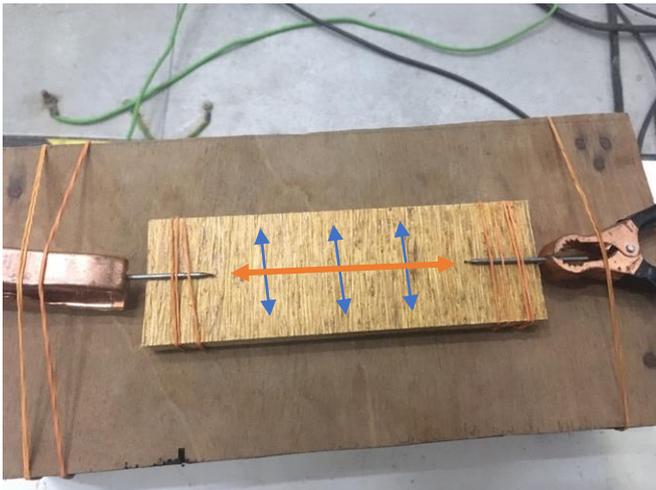
Figure 1: Dry sample with no contamination setup for perpendicular fiber orientation

In order to identify the surface flashover voltage characteristics, two aluminum rods were considered as HV and grounded electrodes (rod-rod configuration) and were placed on top of an OPT plywood sample of dimensions 15cm × 5cm × 1cm, with a gap length of 10 cm between the two electrodes. The rods were aligned in a straight line through the center of the sample and fastened to the sample with rubber bands as shown in Fig 1 and Fig 2.

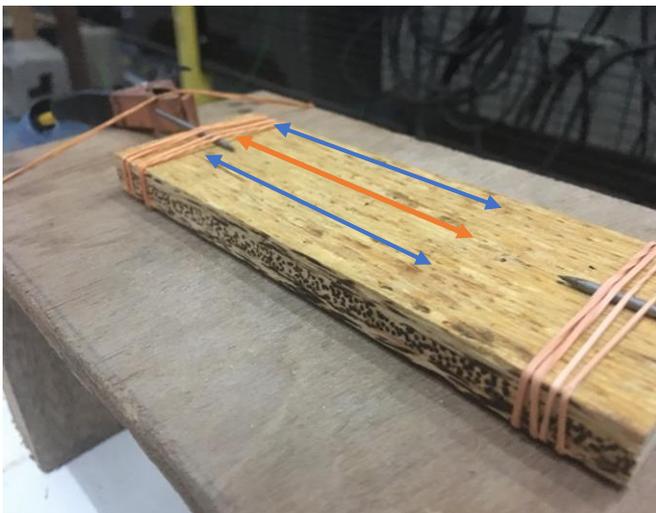
Figure 2: Dry sample with no contamination setup for parallel fiber orientation

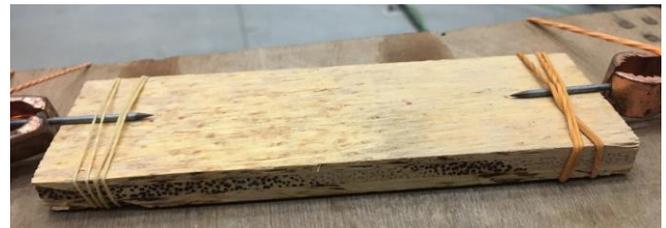
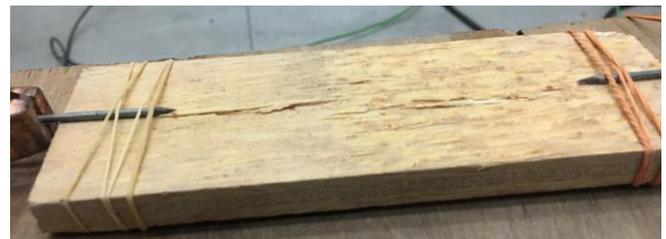
Figure 3: Bentonite contaminated sample with parallel fiber orientation before and after 25 voltage impulses (12 breakdowns)

Results of the experiment are illustrated in Table 1. Highest 50% breakdown voltage is recorded for the sample with fibre orientation parallel to the gap length and the surface is clean and dry. After the application of up and down method, the surface of the sample showed fractures and damage to the fibres. However, the highest observed damage and fractures to the fibres were present in the sample with fibre orientation parallel to the gap length and the surface was contaminated with bentonite, illustrated in Fig 3.

The area of the damage is clearly visible along the channel of the current at breakdown between the rods.  $V_{50\%}$  was significantly lower in the wet sample with fibre orientation parallel to the gap length. However, in this case, the standard deviation was almost comparable with the  $V_{50\%}$  value.
